UM-3724-98
1998 Dodge Durango

In-depth Vehicle Occupant Report

The University
of Michigan
Transportation
Research Institute

Case Vehicle (A): 1998 Dodge
Type: Durango SLT, 4-door 4 x 4
Driver: 26-year-old male
CDC: 12-FDEW-2

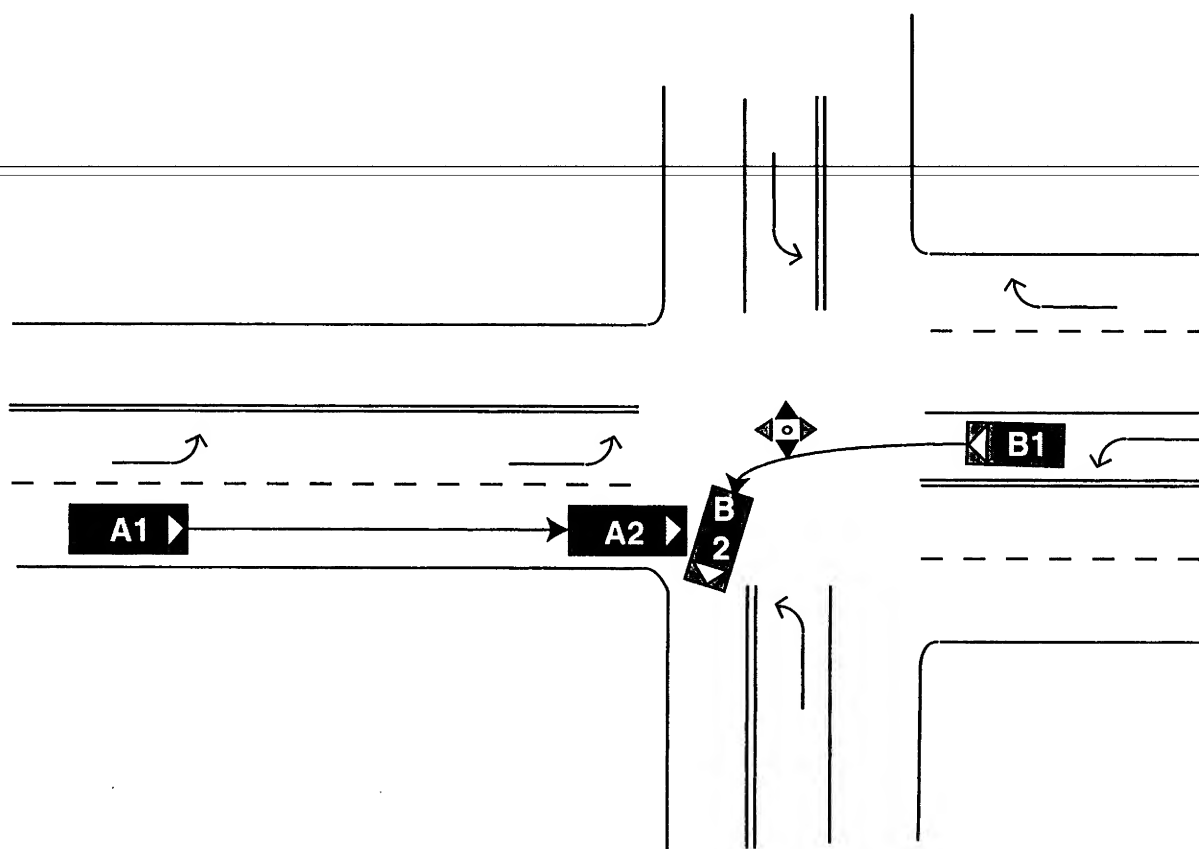
(Slide 1) Case vehicle (A) was traveling north up a slope at a driver-estimated speed of 65 kph (40 mph) in the northbound through lane of a (slide 2) 3-lane asphalt road in a urban residential area. It was daylight, the sky was clear, and the road surface was dry and in good condition. Vehicle (B) was traveling south in the left-turn lane of the same road. Vehicle (B) made a left turn and went into the path of case vehicle (A). Case vehicle (A) was unable to stop in time and struck vehicle (B) in the left side with its front. Vehicle (B) was not available for inspection.

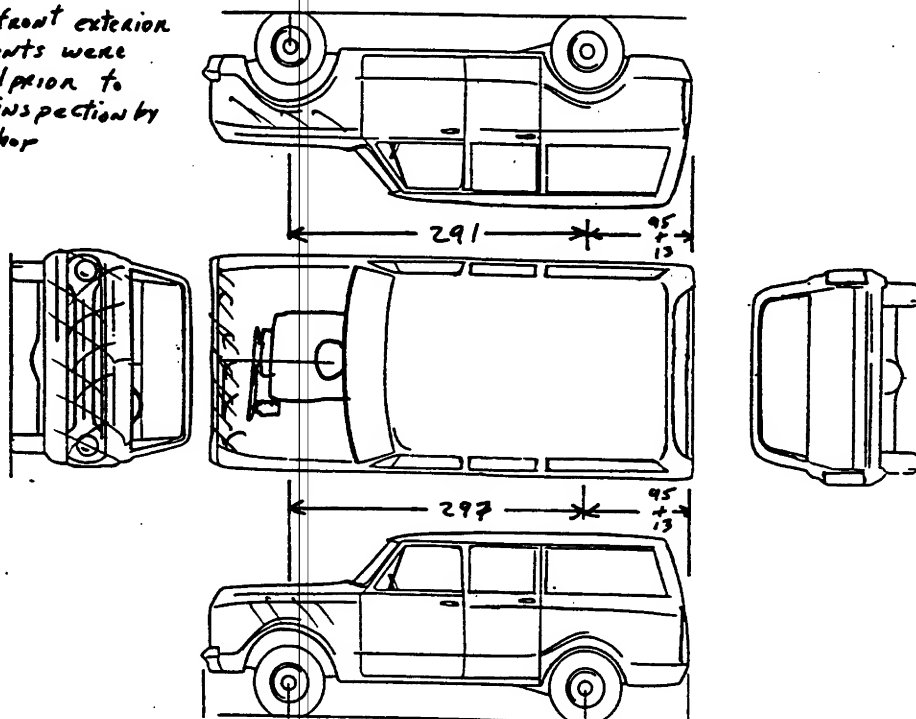
VEHICLE DAMAGE

*All front exterior
components were
removed prior to
vehicle inspection by
body shop*

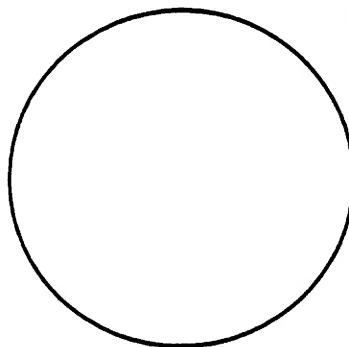
NOTE AND DESCRIBE ANY AIRBAG CONTACT OR
DAMAGE ON DIAGRAM BELOW:

AB 64 W
52 TNO VENTS
1 FLAP
10 1/2 T
15 W

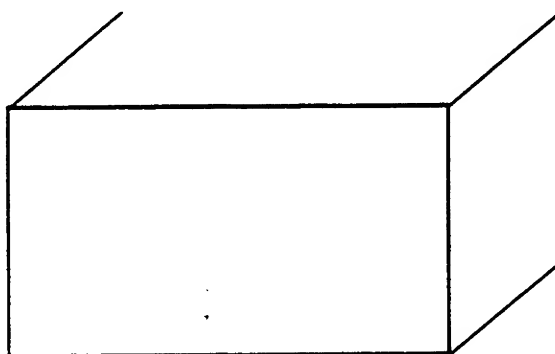
NOTE AND DESCRIBE ANY AIRBAG CONTACT OR
DAMAGE ON DIAGRAM BELOW:

NO VENTS
FLAP 33 W
23 T
AB
52 W
49 T
